CHAZY LAKE DAM

INVENTORY No. NY 236

PHASE I INSPECTION REPORT
NATIONAL DAM SAFETY PROGRAM

AUGUST 1981

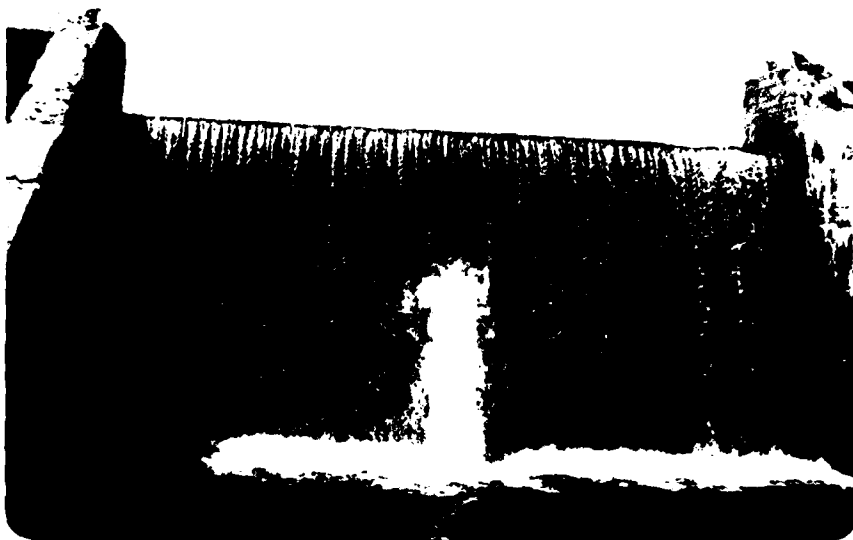
1
wing wall. This cracking again is not explained by the normal forces which would be expected on such a facility. The center buttress which supports the core wall near the center of the spillway also showed some signs of deterioration when viewed through the cascading water.

2. PRINCIPAL SPILLWAY.
TOP PORTION OF
CENTER BUTTRESS IS
DETERIORATED

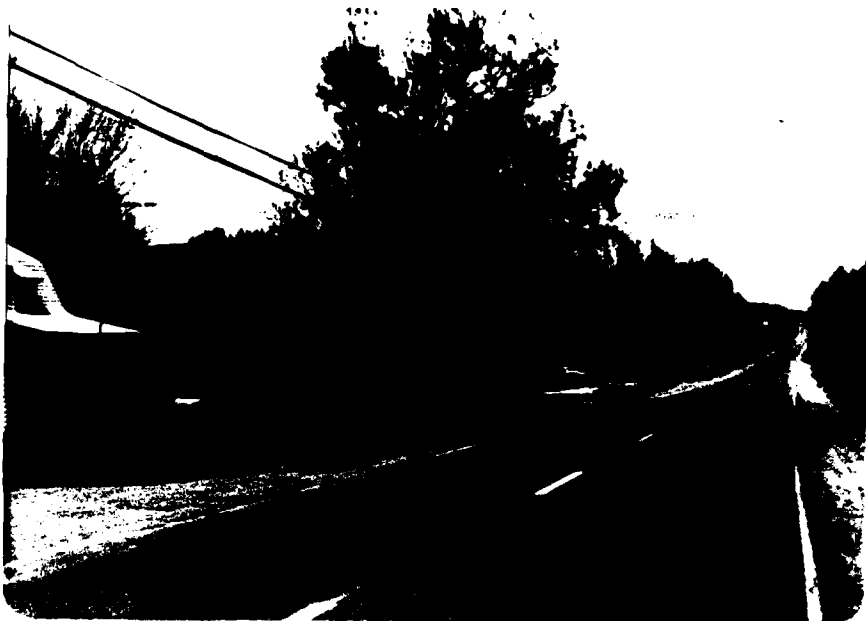
15. DOWNSTREAM HAZARD.
BRIDGE OVER RECEIVING
STREAM IN BACKGROUND
